Incident Information Release

SAFEWORK NSW

IIR Publication number: IIR20190401

Incident date: 1/04/2019
Event: Scaffold Collapse
Location: Macquarie Park

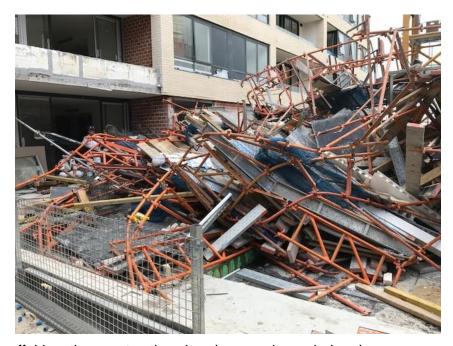
Two formworkers were working on a multi-storey mixed-use construction in Macquarie Park. They were on a concrete slab working beside the base of scaffolding approximately 9 stories high when it collapsed, crushing both workers. One worker was transferred to hospital with critical injuries while the other died at the scene.

Image: Collapsed scaffold on the construction site where work was being done.

- Ensure the scaffold is stable at all times, including during erection, in situ, during and after any alterations, and when dismantling.
- Ensure the scaffold can withstand all anticipated loads, including the weight of workers, all stored material and any loads due to weather such as wind and rain (particularly where containment sheeting is used).

- Ensure the scaffold is adequately tied to its supporting structure, in accordance with instructions from a competent person. Consult with the scaffold designer, manufacturer, supplier or an engineer, and prevent unauthorised removal or changes.

- Ensure altering or partially dismantling the scaffold does not weaken it, e.g. removing returns or adjacent bays may require additional ties or bracing on the remaining scaffold.
